Boot Problem Solution.

开机异常解决方法

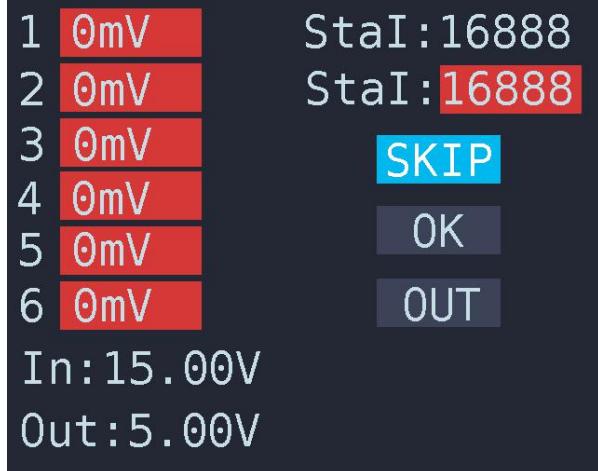
After booting, do not enter the main interface, but stay in the abnormal interface, as shown below.

1. After upgrading the new firmware, the old firmware is returned, resulting in incompatible data structure and loss of calibration data.
2. An irrelevant file is written to the device U disk, causing the calibration data to be overwritten.

1. Upgrade to the latest firmware.
2. Enter the manual calibration mode (M6 press the exit button when the LOGO interface is displayed, M8 and M8S press and hold the turntable to start).
3. Move the cursor to the factory value and confirm.
4. Calibrate each voltage (input, output, balance port).
5. Save and exit to complete the repair.

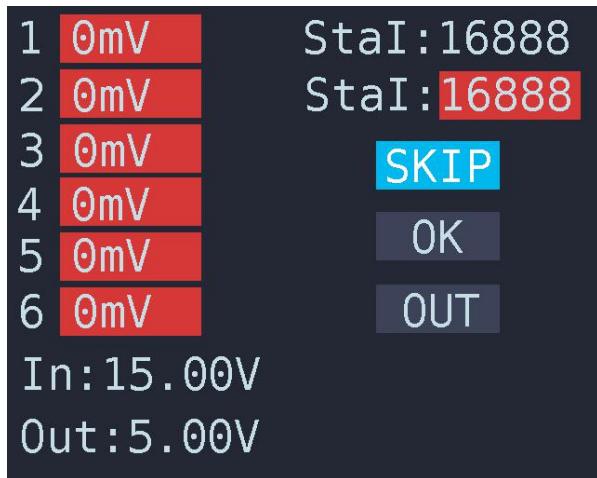
开机后不进入主界面，而停留在异常界面，如下图。

- 1, 升级新固件后，退回旧版固件，导致数据结构不兼容，校准数据丢失。
- 2, 向设备 U 盘写入了不相关文件，导致校准数据被覆盖。

- 1, 升级至最新固件。
- 2, 进入手动校准模式(M6 在显示 logo 界面时按一次退出键, M8 和 M8S 按住转盘开机)。
- 3, 光标移动至出厂值，并确认。
- 4, 校准各项电压(输入, 输出, 平衡口)。
- 5, 保存并退出，完成修复。
